SS SANSINENA (LIBERIAN); EXPLOSION AND FIRE IN LOS ANGELES HARB--ETC(U)

1. Report No. USCG-16732/71895	2. Government Accession No.	3. Recipient's Catalog No. 11
4. Title and Subtitle Marine Board Casualty Report SS SANSINENA (Liberian); Explosion and Fire in Los Angeles Harbor, California on 17 December 1976 with loss of life.		5. Report Date 25 Nov 1977

SS SANSINENA (LIBERIAN); EXPLOSION AND  
FIRE IN LOS ANGELES HARBOR, CALIFORNIA  
ON 17 DECEMBER 1976 WITH LOSS OF LIFE

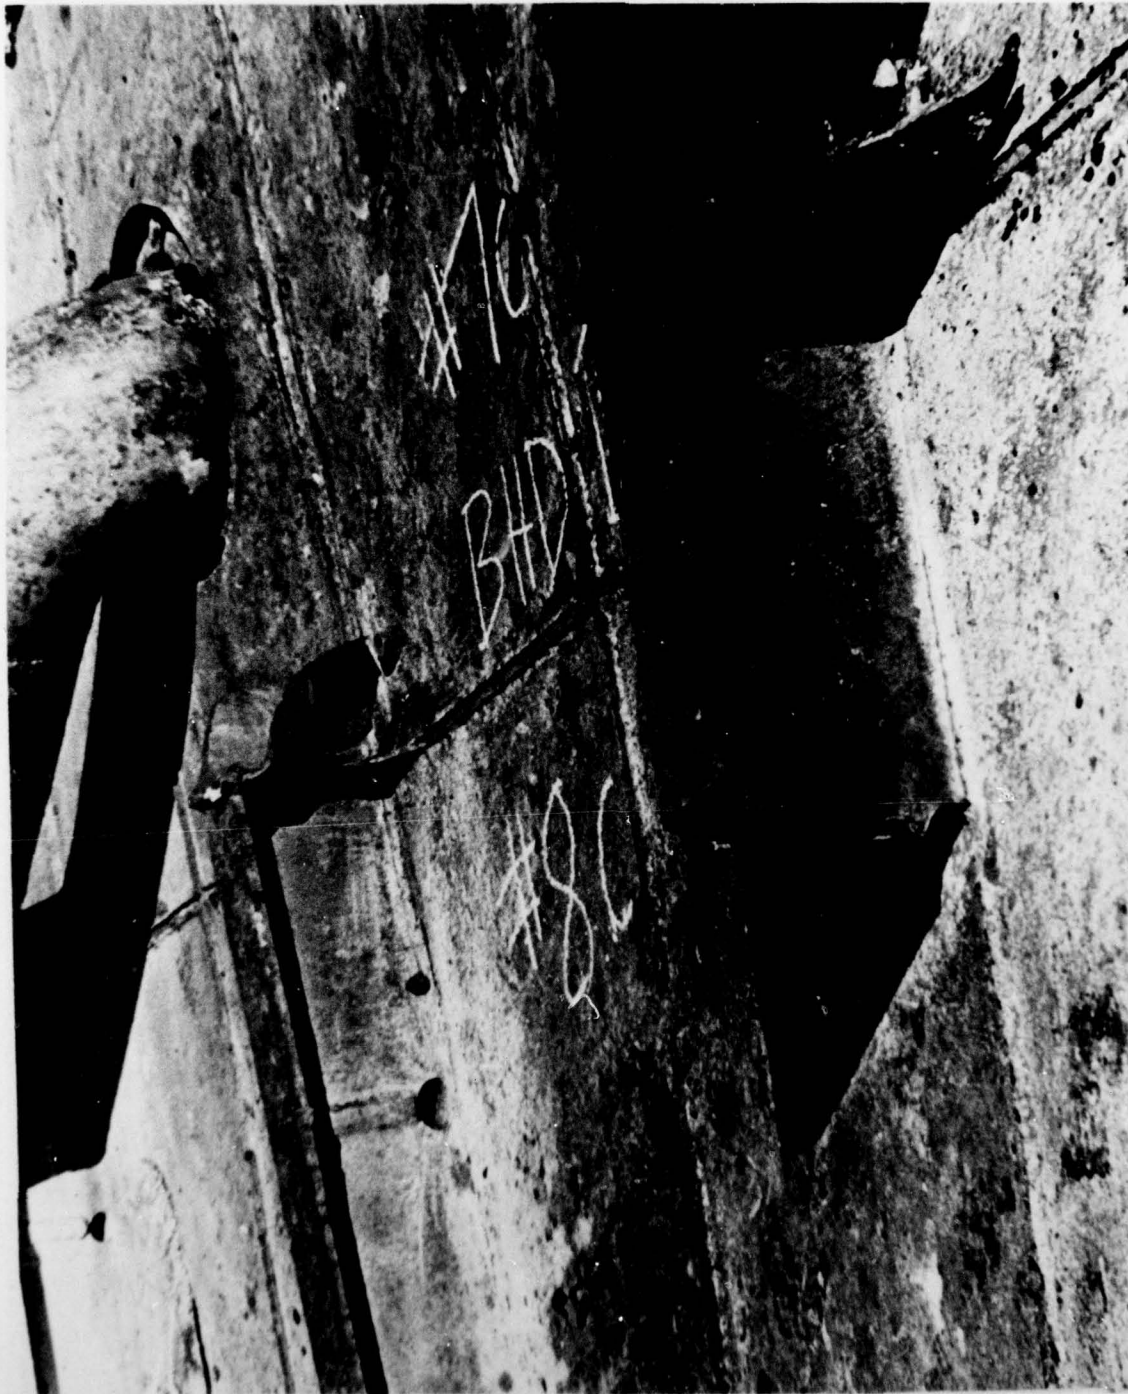
tank were bent forward, all abaft #10 tank were bent aft. (Figure 5.) There were no bits of the #10 longitudinal bulkheads left attached. However, a close examination of the broken continuous fillet welds along those bulkhead lines revealed that on the outboard sides the remaining welds were lower on average and were beveled outward from the bulkhead's former position, while the opposite broken fillets were higher and were slightly "hooked" toward where the bulkhead had been. (Figure 6 typical.) The bulkhead fragments indicated clearly the direction of bulkhead displacement. There were consistent findings that the beveled fillets were on the side toward which the bulkhead fragments were bent, with the slightly "hooked" edge higher on the opposite fillets.

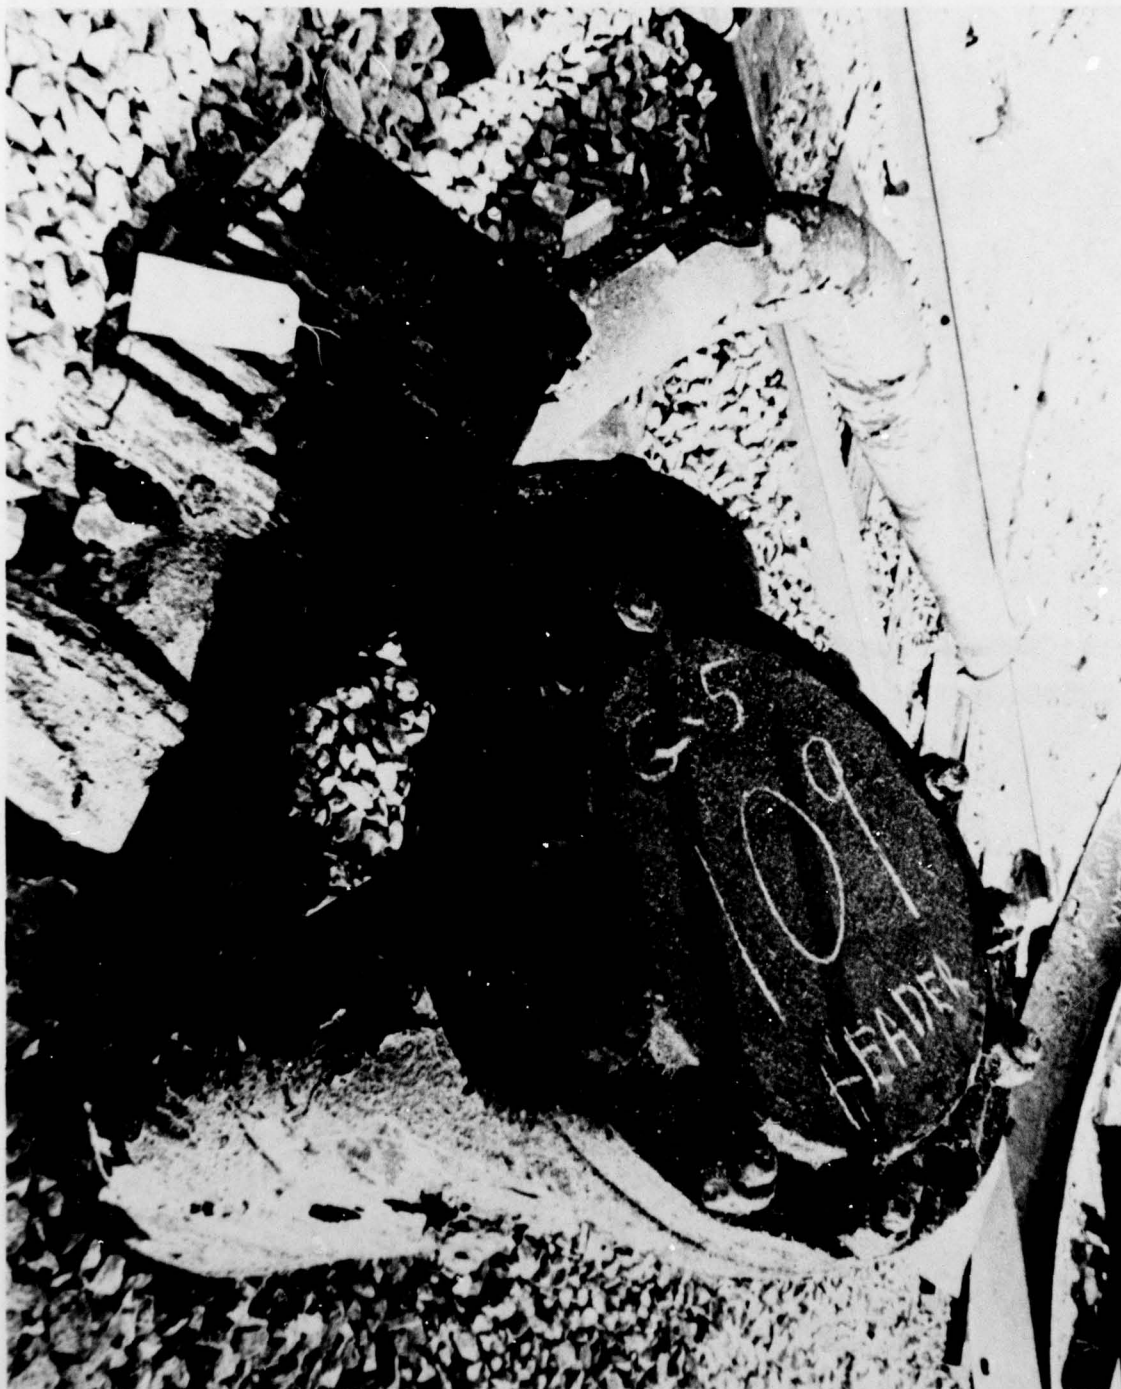
The integrity of the cargo vent system was compromised by numerous wastage holes on the underside of the cargo vent piping, a missing washout nipple cap, and a missing drain plug. The lack of integrity in the cargo vent piping further negated the dissipating effect of the weather head vent stacks at the top of the kingposts and contributed to the accumulation of hydrocarbon vapors on deck in the cargo tank area. The inspection procedures of the cargo vent system by the shipboard personnel, classification society inspectors, inspectors for the Government of Liberia, and company inspectors were inadequate to detect the relatively extensive deterioration that existed on the underside sections of the cargo vent piping. Furthermore, this lack of integrity allowed the vent piping to serve as a path of transmission for a flame to enter the cargo tanks.

d. Examination of pieces of the cargo tank vent piping, including the branch lines and the common header revealed numerous areas of localized wastage. Several pieces were found with holes wasted through on their undersides. (See figures 7 through 8 for examples.) Examination of the area surrounding these holes revealed that the holes were primarily the result of internal corrosion. Much of this piping had a very heavy buildup of exterior paint, as much as 1/8-inch thickness in places. Various samples of the cargo vent piping and a typical P/V valve were analyzed by the Aerospace Corporation in an effort to characterize the corrosion behavior. Generally, uniform corrosion of the bottom portion of the vent piping was noted to be at least twice and at some places up to four times the normally expected corrosion rate for galvanized steel in a marine environment. Further, localized deeper pits and holes in the vent header pipes in the vicinity of P/V valve connections were attributed to either galvanic action between the steel pipes and copper products from the P/V valves or action of a hydrochloric acid solution in areas of initial breakdown of the protective zinc coating. The analysis also concluded that the corrosion holes studied were covered by a thick external paint coating prior to the explosion.

6. The recommendation that every cargo venting system at an age of 10 years be surveyed to determine its material condition, including the removal of all P/V valves and audiogauging of the underside of the piping directly under the P/V valves is concurred with in part. The Merchant Marine Technical Division will conduct a detailed physical and metallurgical examination on a representative number of tank vessels in various trades over the next 5 years to determine needed inspection intervals. In the interim the program of examining tanker venting systems, which was initiated as a result of this casualty, will be continued. Also, the scope and interval of examinations to be conducted aboard tankers is being thoroughly discussed at IMCO and a proposal will be presented at the Plenipotentiary Conference
